An investigation of the Brumadinho Dam Break with HEC RAS simulation

Arun Raman¹, Fei Liu²

¹ *New Jersey West Windsor - Plainsboro High School N*

Abstract

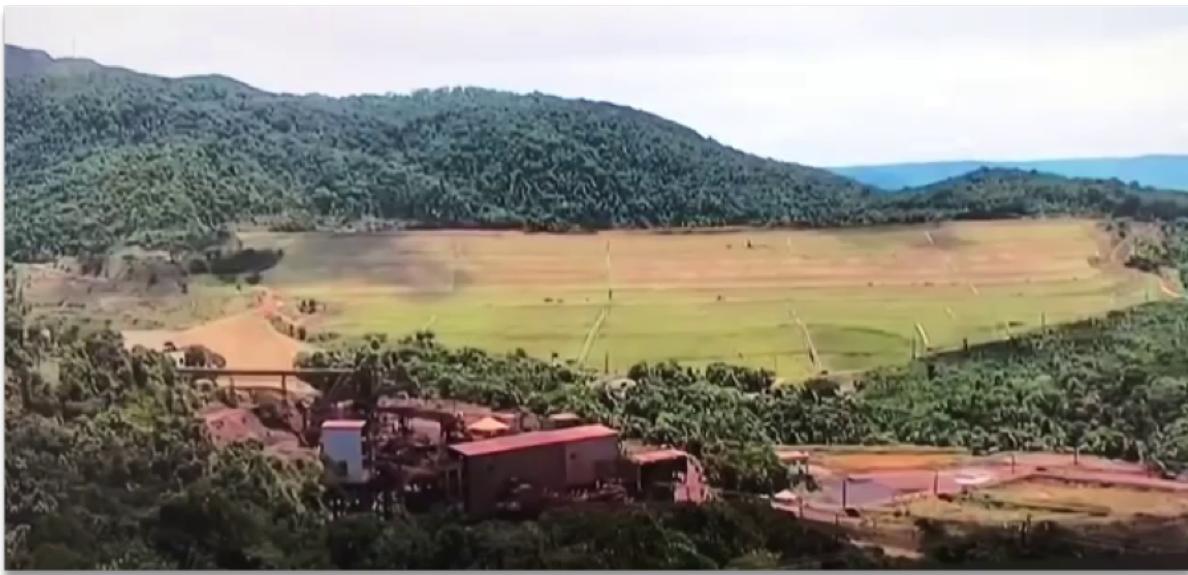
It is believed that sliding is the most likely cause of dam failure. From Figure 2, it is visible that the bottom portion of the dam is slowly creeping forward. This action diminishes the stability of the top portion, causing a total collapse and subsequent flood. The failure was caused by a design error present in upstream tailings dam. Evidence from the video footage suggests that the Brumadinho dam failure can be explained by the analysis presented in [21] and mismanagement of the mining company. Tailings dam requires continual monitoring for potential safety risks as the risk of failure increases with time, often inadequately examined in a laboratory environment. As noted in [21], an August 2018 (5 months before the failure) audit of the Brumadinho dam yielded the conclusion that the dam was stable.

Figure 2: Dam at the moment of the collapse

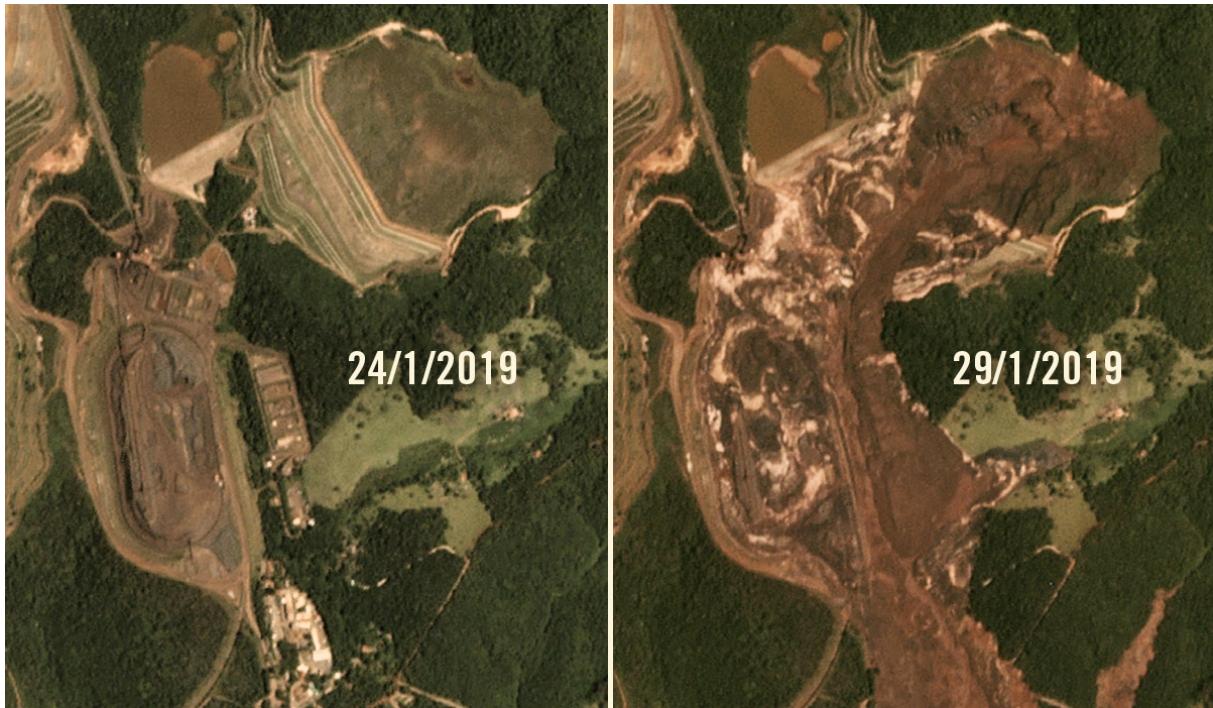
The Brumadinho dam broke during local lunchtime and subsequently the mud stored in the dam flew to the Paraopeba river after around 3 hours from the initial break. The event lasted a few more days as mud kept creeping both upstream and downstream along the river. The effect of the dam break near the dam can be seen in Figure 3 [22]. Due to the unfortunate timing of the break, most casualties took place in the dam worker's cafeteria as it was lunch hour when the dam broke.

Figure 3: Satellite image of the dam before and after the dam break

The set up of the dam and breach plan is shown in Figure 8, which demonstrates that the left side of the dam is significantly lower than the right. This led to more significant erosion occurring to the left side of the breach during the dam break as can be seen in Figure 3.

The Brumadinho dam break, due to mishandling of mining waste and inadequate dam maintenance, caused significant human life and property loss. Such a tragedy could have been avoided if simple precautions were taken. For instance, it was erroneous to place the work lounge and cafeteria on the low-ground directly beneath the dam. The majority of the human casualties due to this event would have been avoided if the lounge and cafeteria were placed on the high ground on the right side of the dam. It can be seen from Figure 3 that the right side of the dam was largely intact due to its elevation.

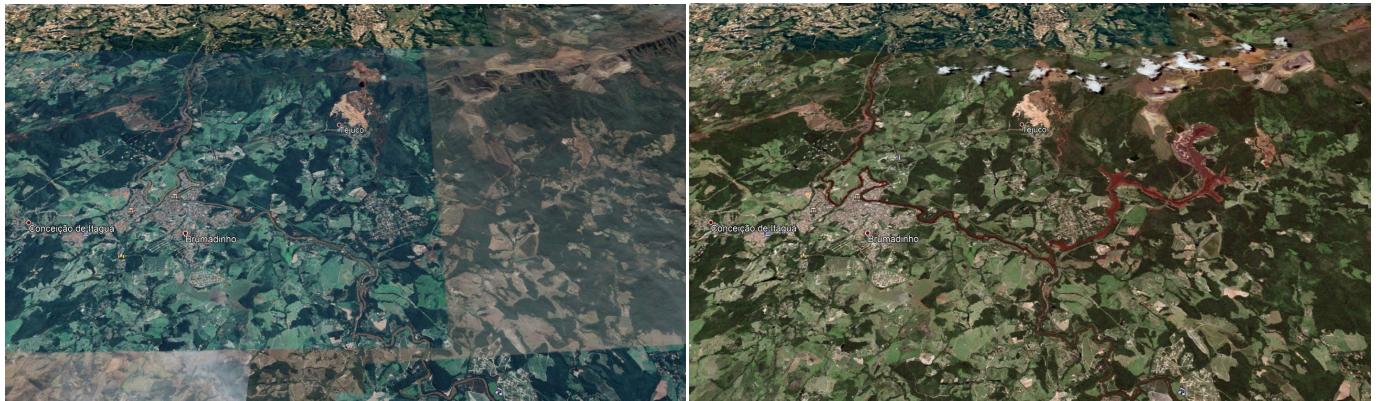
The dam's destruction destroyed much of the city of Brumadinho as well as the surrounding landscape and infrastructure, including trails and freight railway tracks. The company Vale was responsible for the dam's failure due to neglect of safety regulations and was ordered to pay a fine of \$2.9bn [2]. Downstream from the dam is a narrow canyon leading to the river which was severely flooded by mud during the event as shown in Figure 4 and 5. The exact cause of the dam break has not been discovered. A complete analysis of its aftermath, total number of casualties and cost of property damage, has yet to be released.

Figure 4: The Brumadinho dam in January 2019 before collapse

Figure 5: Extension of the mud-flow along the Paraopeba river

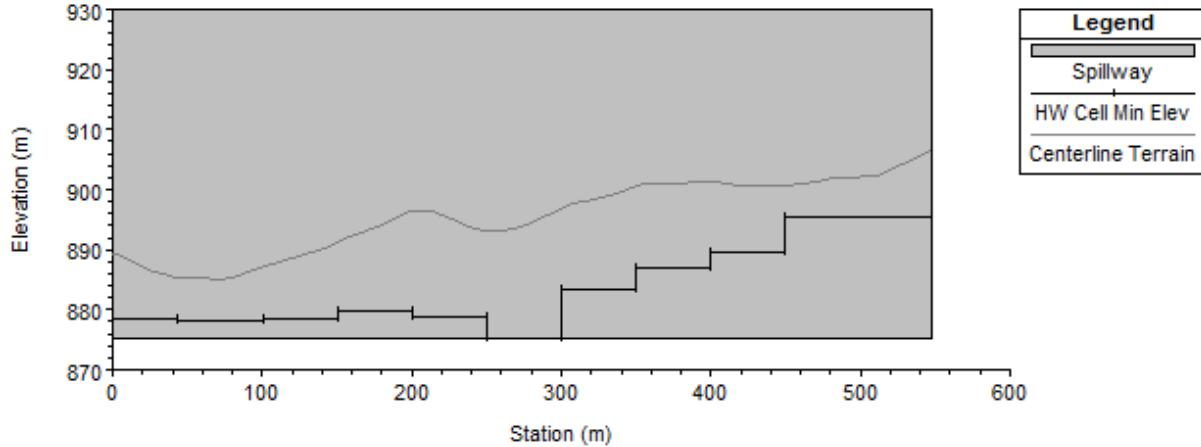
Figure 8: The dam modelled as 2D flow area and storage area connection

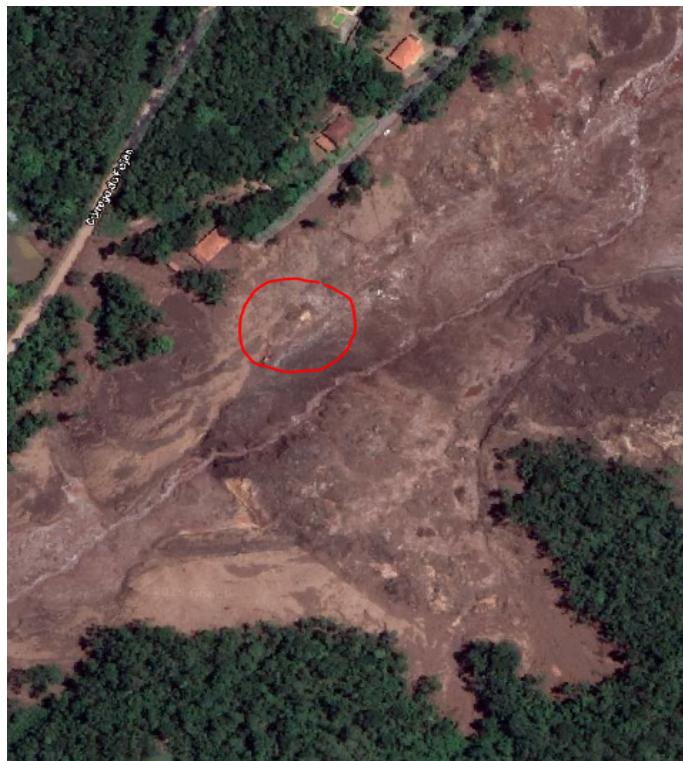
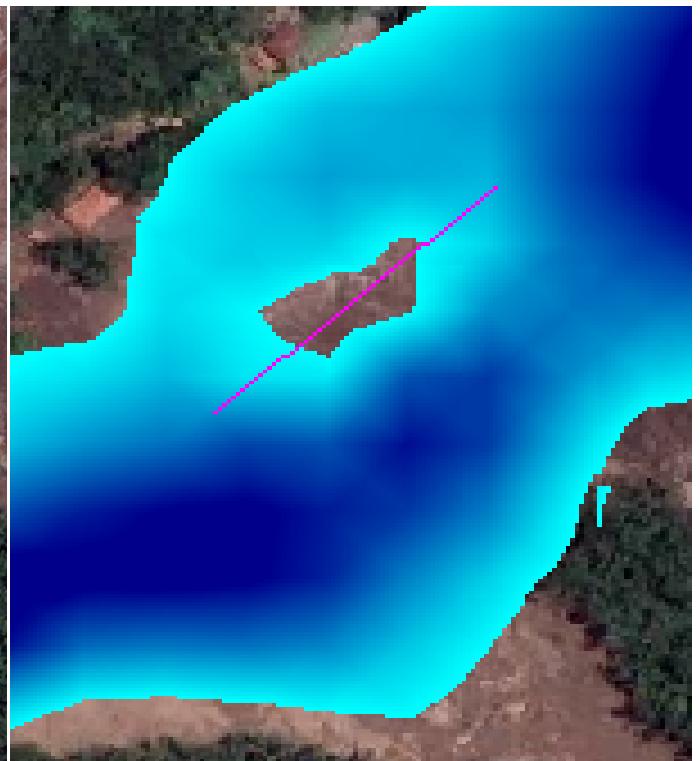
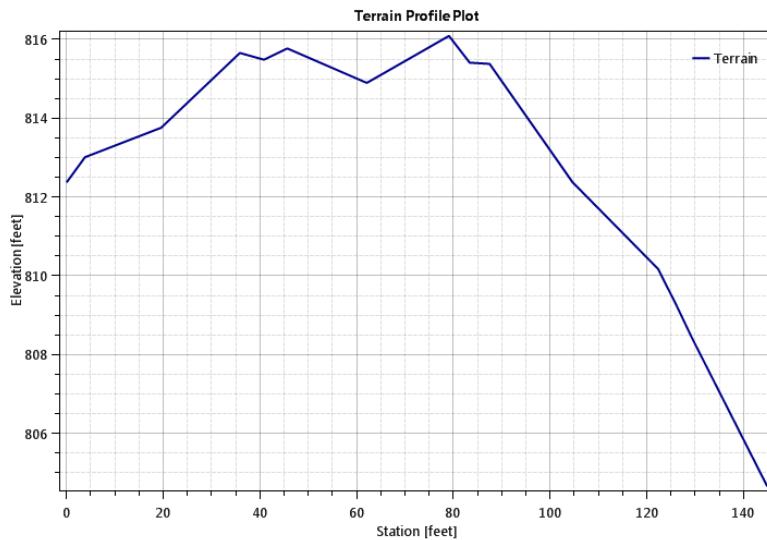
A location of interest is shown in Figure 15 and 16. It can be seen that in the image of the simulated result 16, there is a small area without flooding. Upon closer examination of the

satellite image and the bottom topography height along the line in 16, a local high ground is revealed 17 at this spot that pushes mud flow to circumvent around the local high ground.

Figure 17: Terrain plot of Loc. 3 as shown above
