An investigation of the Brumadinho Dam Break with HEC RAS simulation

Arun Raman¹, Fei Liu²

¹ *New Jersey West Windsor - Plainsboro High School N*

Abstract

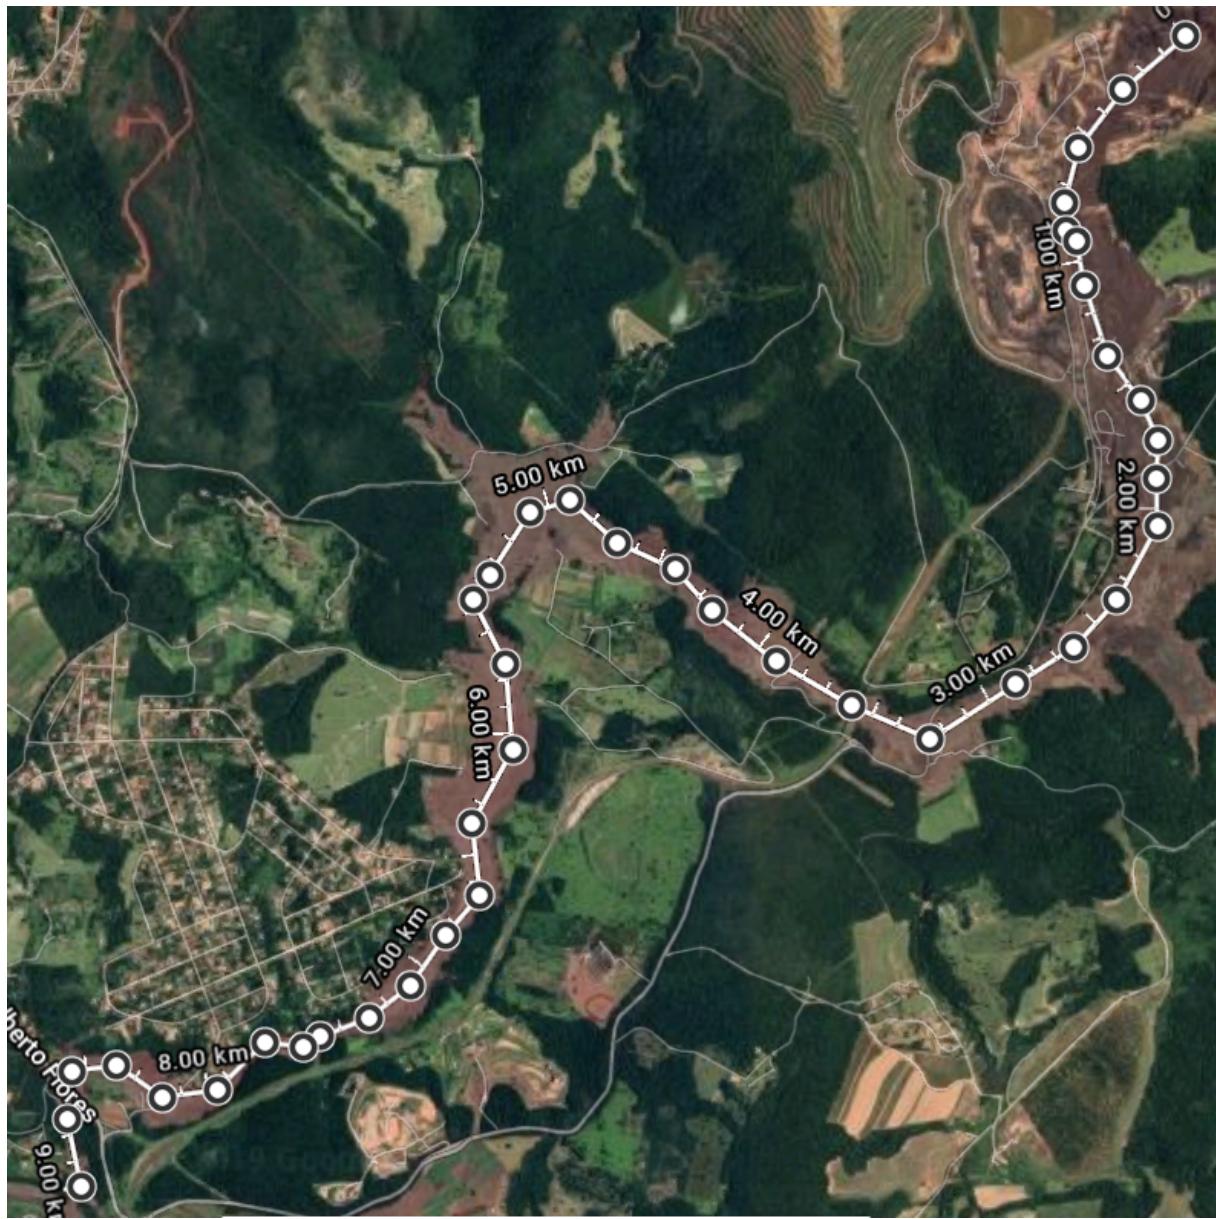
Figure 6: The measure distances of the flow path taken by the mud flow

The Digital Elevation Map (DEM) of the Brumadinho area was made available by NASA's Shuttle Radar Topography Mission (SRTM). This mission produced global 1 arc-second, or about 30 meters resolution, topographic data sufficient for the Brumadinho dam break simulation. As seen in Figure 6, the distance between the Brumadinho dam and Paraopeba river, the primary area where the flooding simulation is carried out, is approximately 9km which is the main area. The European Petroleum Survey Group (EPSG) code 29101 projection correctly geo-references the DEM to Google Satellite images over Brazil.

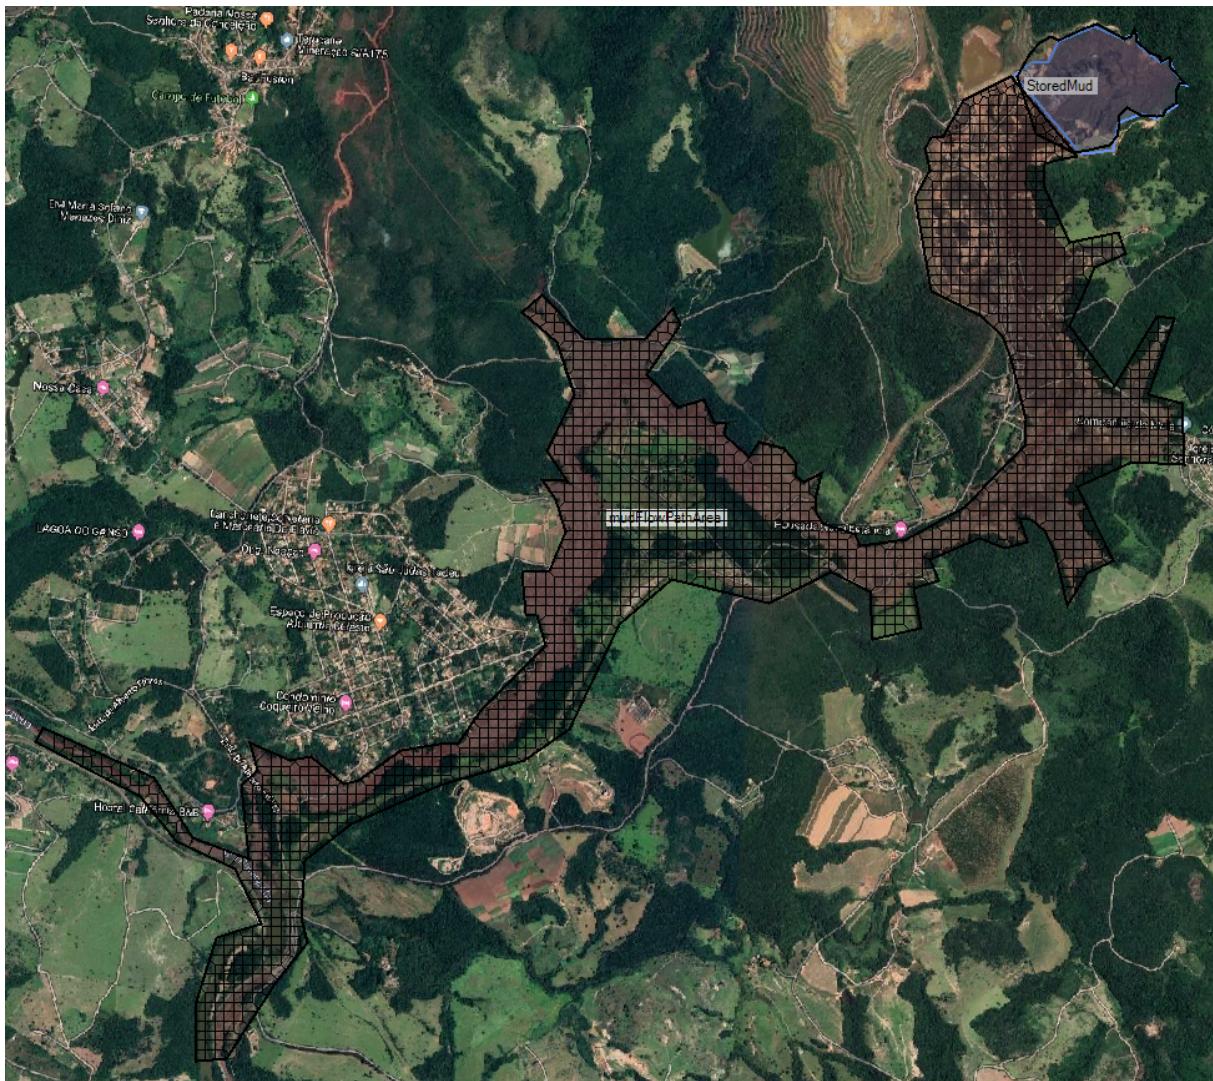
Figure 7: Computational mesh used in HEC-RAS for representing the assumed flow area of the simulation

A 2D flow area is set up with a 50 meter by 50 meter cell size resolution as show in Figure 7, resulting in a computational mesh with 2258 cells to carry out the shallow water equation calculations. A storage area is set up to store the mud with a 2D flow area and storage area connection in between to represent the dam.

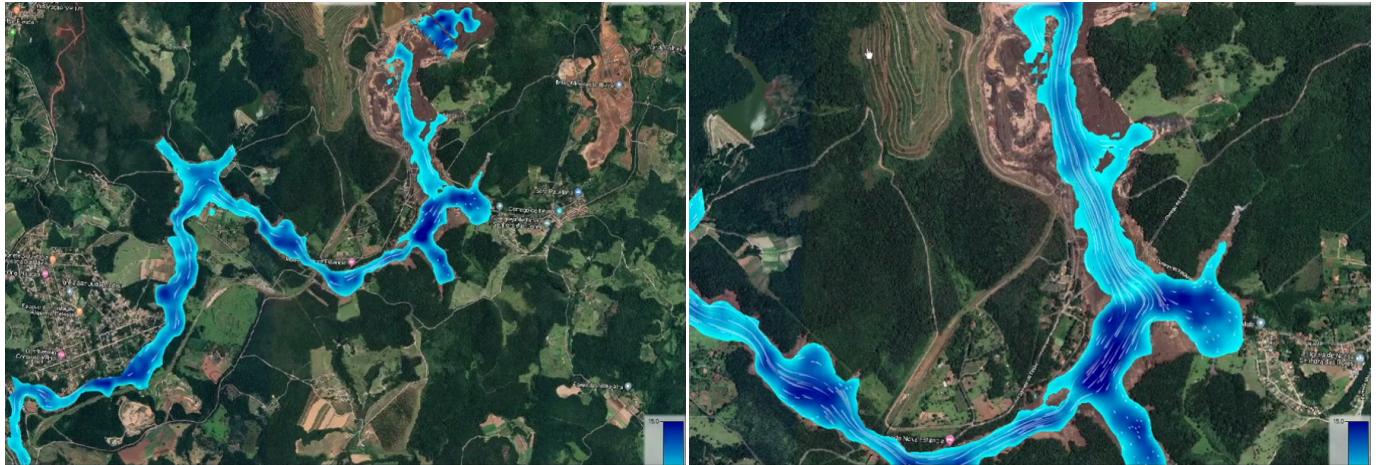
Figure 9: A simulation of the tailings flow area post-collapse

The Manning value for the flow area is set to 0.3 which led to the observed 3 hour flow time from the Brumadinho dam to Paraopeba river. The Coriolis effect is turned off due to the relatively small scale (9 km) and short time (3 hours) involved in the simulation. Figure 9 and Figure 10 show the result of the flooding pattern from the HEC-RAS simulation overlaid on top of the flooded region seen in the satellite image. The correlation between the observed flooding pattern and simulated pattern can be seen from the Figures to be extremely strong.

Figure 10: A closeup of the simulated tailings flow near the dam

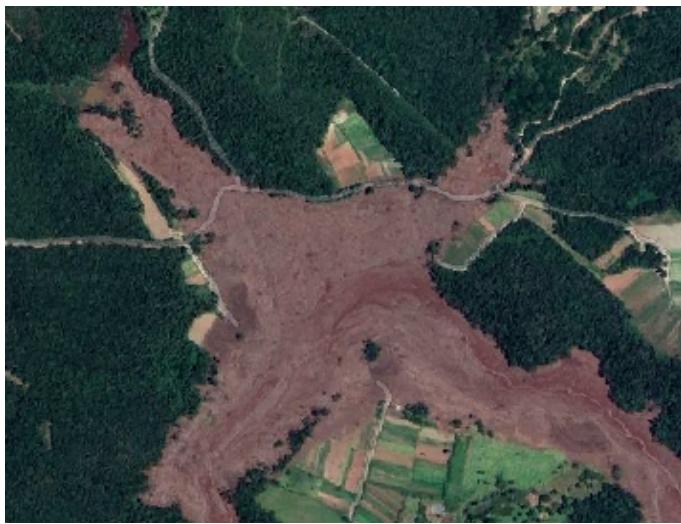
Figure 11: Loc. 1: Satellite Imagery

A few isolated locations downstream from the broken dam are selected where we zoom in to examine the actual flooding and simulated pattern. These can be seen in Figure 11, 12, 13, and 14. The images on the left are satellite images of the locations after the dam break; the images on the right are simulated flooding patterns. This level of similarity is seen in both the overall pattern comparison and at the individual locations examined.
